Manhole Inspection Summary

Manhole # S49K__036MH

Location Address: **703 S Monford Av**

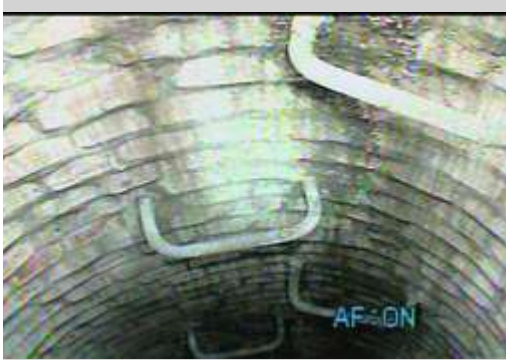
Defect 2

Count: **5** Missing: **0** ☒ **Corroded**

corroded stairs

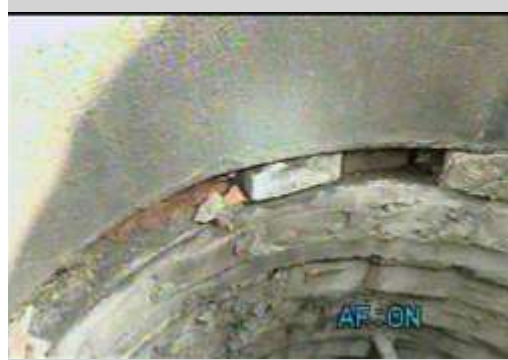
Defect 1

Offset: **2** (in.)

Condition: ☐ Sound ☐ Cracked ☐ Root Intrusion ☒ **Loose Brick** ☐ Deteriorated

off set and loose brick

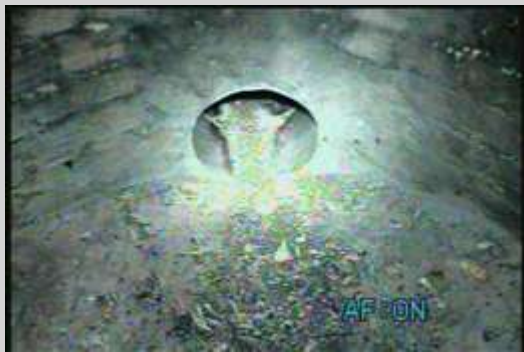
12 O'Clock Outflow

8 in. Circular Gravity Sewer
Pipe Out @ 12 O'Clock

Pipe Material: **Clay** ☐ Pipe Lined

Invert Depth: **9.75** (ft.) Flow Characteristics: **None**

Deposits: ☒ None ☐ Mud ☐ Sludge ☐ Debris ☐ Grease

Infiltration: **None** Pipe Seal Cond: **Unknown**
